Mountain View
Whisman
School District

MVWSD MASTER FACILITIES PLAN

November 2019

Mountain View Whisman School District Roof Assessment

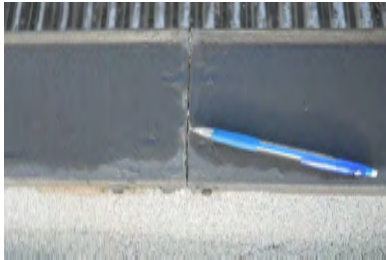
Typical Deficiency - Sealant at coping seams has begun to fail. Recommend removal and replacement of sealant as needed.

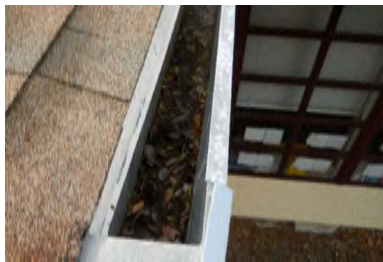
Typical Deficiency - Gutters are full of debris. Recommend clearing debris from all gutters, drains, waterways, and field of roof to promote positive drainage.

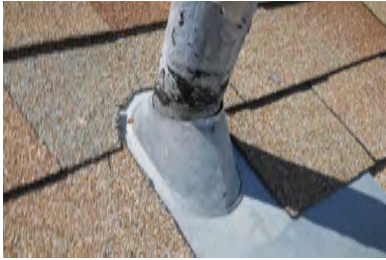
Typical Deficiency - Pipe jacks are missing sealant. Recommend application of flexible flashing self-adhered tape and or sealant, and install storm collar.

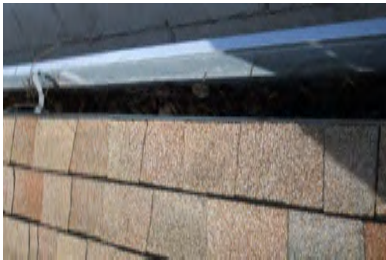
Typical Deficiency - Gutters are full of debris. Recommend clearing debris from all gutters, drains, waterways, and field of roof to promote positive drainage.

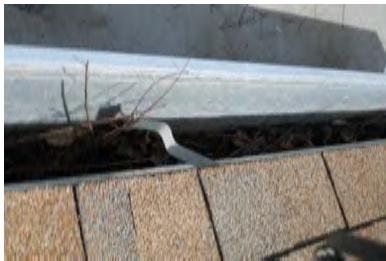
Typical Deficiency - Gutter straps need to be re-fastened.

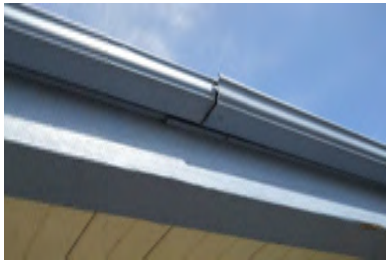
Typical Deficiency - Damaged gutter seam.
Recommend repair as needed.

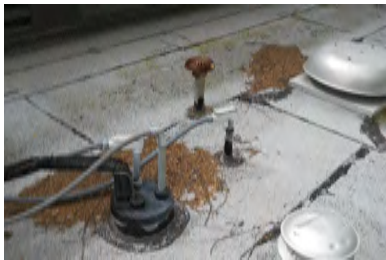
Typical Deficiency - Observed accumulation of debris at field of roof. Recommend clearing debris from all gutters, drains, waterways, and field of roof to promote positive drainage.

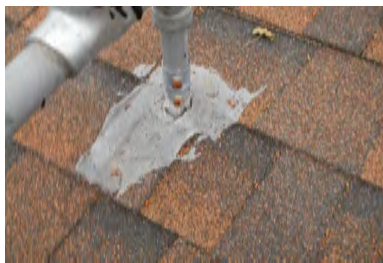
Typical Deficiency - Through roof penetrations do not appear to have proper roof jack. Recommend installing proper roof jack and storm collar.

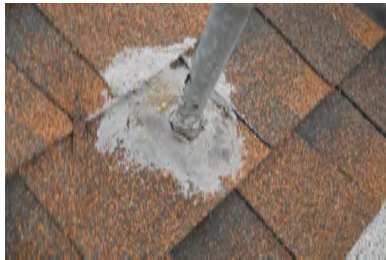
Typical Deficiency - Through roof penetrations do not appear to have proper roof jack. Recommend installing proper roof jack and storm collar.

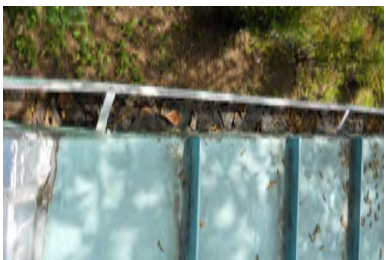
Typical Deficiency - Gutters are full of debris. Recommend clearing debris from all gutters, drains, waterways, and field of roof to promote positive drainage.

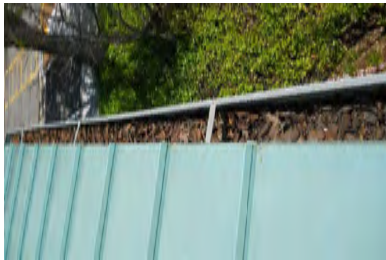
Typical Deficiency - Gutters are full of debris. Recommend clearing debris from all gutters, drains, waterways, and field of roof to promote positive drainage.

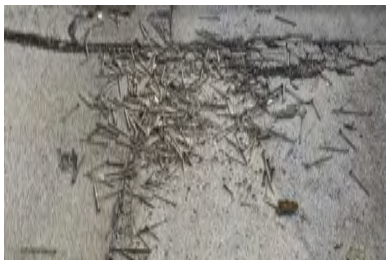
Typical Deficiency - Debris have accumulated at field of roof. Recommend clearing debris from all gutters, drains, waterways, and field of roof to promote positive drainage.

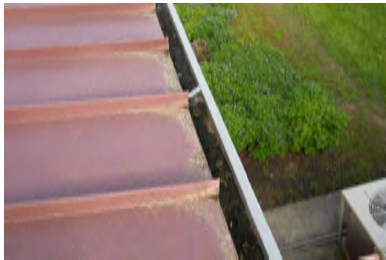
Typical Deficiency - Gutters are full of debris. Recommend clearing debris from all gutters, drains, waterways, and field of roof to promote positive drainage.

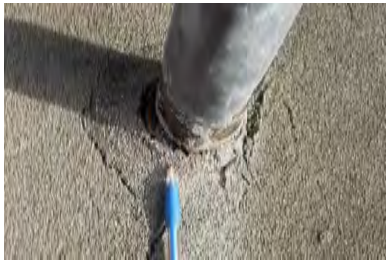
Typical Deficiency - Detailing at through roof penetrations show signs of cracking and delamination. Recommend touch up of mastic at penetrations and application of acrylic or silicone coating to preserve and maintain repair.

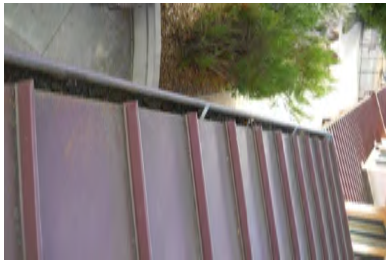
Typical Deficiency - Gutters are full of debris. Recommend clearing debris from all gutters, drains, waterways, and field of roof to promote positive drainage.

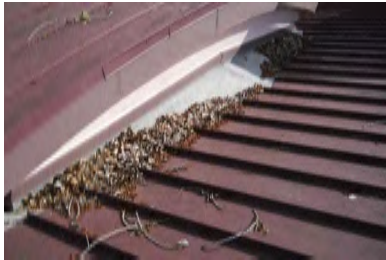
Typical Deficiency - Debris have accumulated at field of roof. Recommend clearing debris from all gutters, drains, waterways, and field of roof to promote positive drainage.

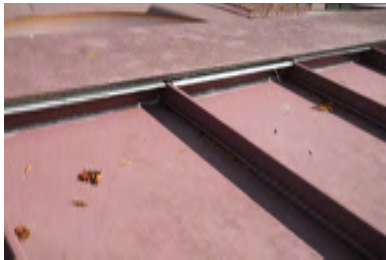
Typical Deficiency - Ridge closure pieces have buckled. Recommend removal and reinstallation as needed.

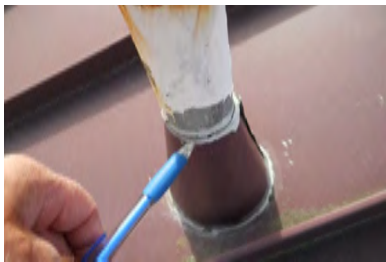
Typical Deficiency - Pipe jacks are missing sealant. Recommend application of flexible flashing self-adhered tape and or sealant, and install storm collar.

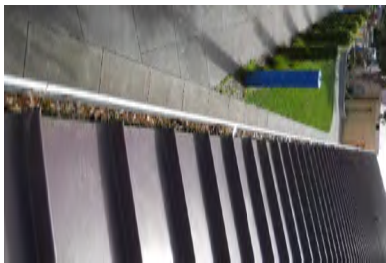
Typical Deficiency - Gutters are full of debris. Recommend clearing debris from all gutters, drains, waterways, and field of roof to promote positive drainage.

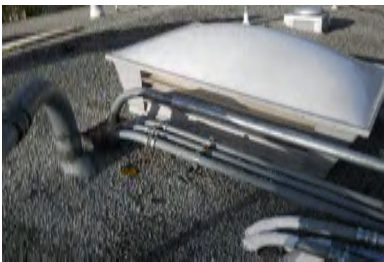
Leak Reported Below. Recommend further review and assessment.

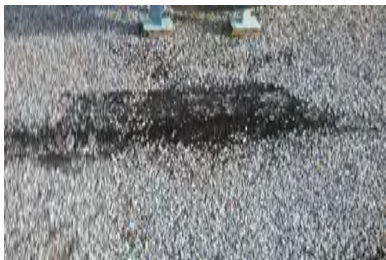
Typical Deficiency - Areas of displaced gravel. Recommend re-distributing and adhering gravel over bare areas to protect underlying membrane from exposure to UV .
