Mountain View
Whisman
School District

MVWSD MASTER FACILITIES PLAN

November 2019

Mountain View Whisman School District Roof Assessment

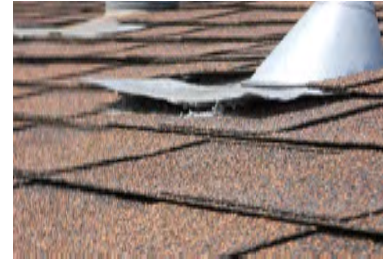
Typical Deficiency - Pipe jacks are damaged. Recommend installing new GSM roof jack and storm collar.

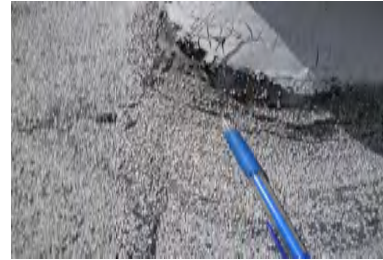
Typical Deficiency - Detailing at through roof penetrations show signs of cracking and delamination. Recommend touch up of mastic at penetrations and application of acrylic or silicone coating to preserve and maintain repair.

Touch up of mastic at penetrations and apply acrylic or silicone coating to preserve repair.

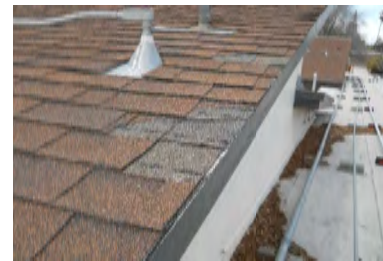
Typical Deficiency - Shingles are missing. Recommend replacing as needed.

Replace missing shingles as needed.

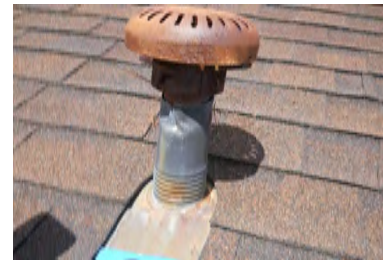
Typical Deficiency - Pipe jacks are missing band clamps and sealant. Recommend installing stainless steel band clamps, apply sealant, and install storm collar.

Install stainless steel band clamps and storm collars as needed.

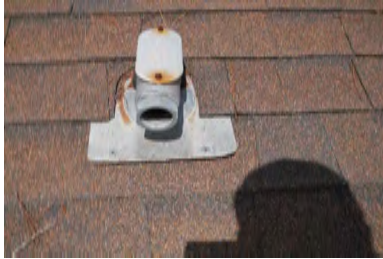
Typical Deficiency - Pipe jack is in need of replacement. Recommend installing new roof jack and storm collar. Recommend LB to be removed if abandoned.

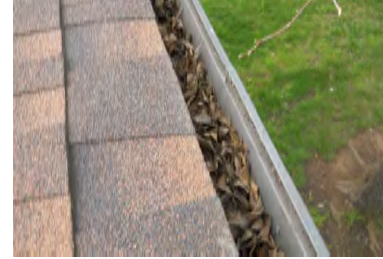
Typical Deficiency - Gutters are full of debris. Recommend clearing debris from all gutters, drains, waterways, and field of roof to promote positive drainage.

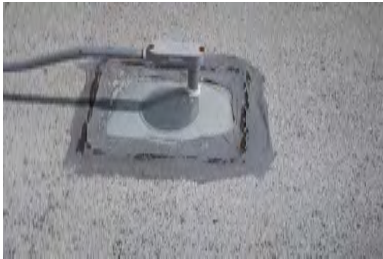
Typical Deficiency - Conduit penetrations do not appear to have proper roof jack. Recommend installing proper roof jack and storm collar.

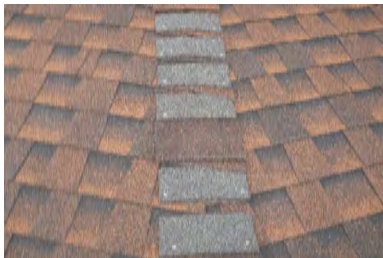
Typical Deficiency - Hip and ridge shingles are missing. Recommend replacing as needed.

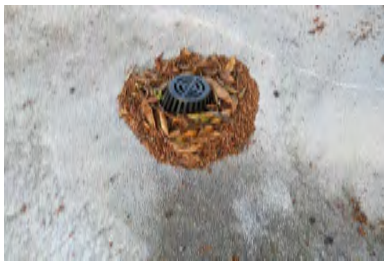
Typical Deficiency - Debris have accumulated at field of roof. Recommend clearing debris from all gutters, drains, waterways, and field of roof to promote positive drainage.

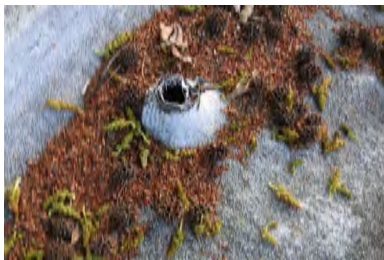
Typical Deficiency - Pipe jack at through roof penetration is damaged. Recommend repairing as needed.

Repair pipe penetration.

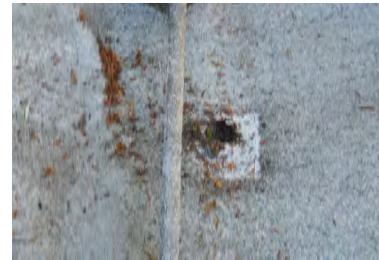
Typical Deficiency - Coating has begun to delaminate from foam roofing. Recommend touch up as needed.

Repair damaged coating.

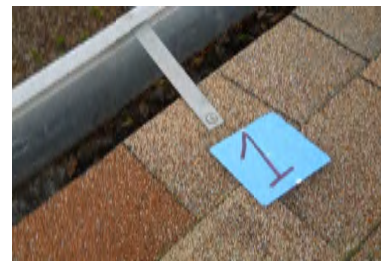
Typical Deficiency - Gutter brackets have been face fastened through asphalt shingle. Recommend removal and repositioning bracket. Repair asphalt shingles as needed.

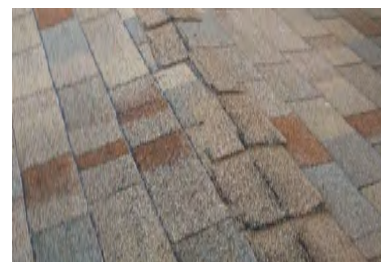
Typical Deficiency - Hip and ridge shingles are damaged and missing. Recommend replacing as needed.

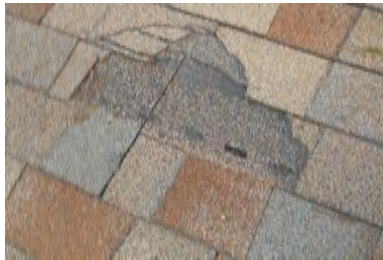
Typical Deficiency - Asphalt shingles are damaged and missing. Recommend replacing as needed.

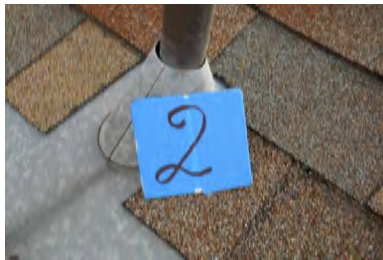
Typical Deficiency - Pipe jacks are missing sealant. Recommend application of flexible flashing self-adhered tape and or sealant, and install storm collar.

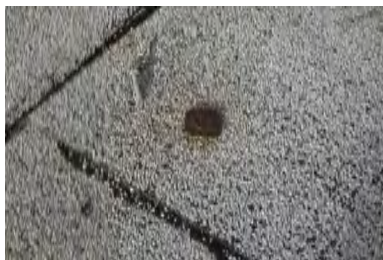
Typical Deficiency - Observed fastener penetrating through finished built-up roofing. Recommend removal and patch.

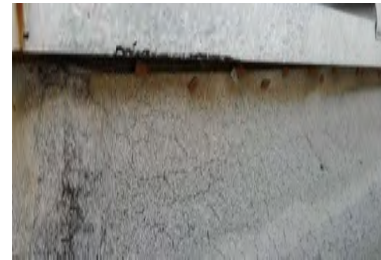
Typical Deficiency - Base flashing at mechanical curb has not been properly skirt flashed. Recommend installation of GSM skirt flashing.

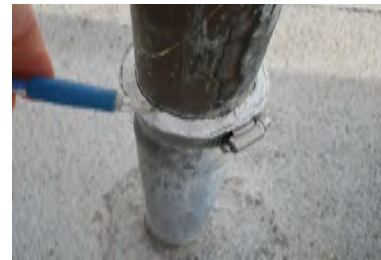
Typical Deficiency - Sealant at lead pipe jacks has begun to pull away from through roof penetration. Recommend replacing sealant as needed, installing stainless steel band clamps, and storm collar.

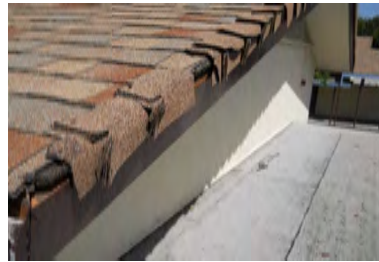
Typical Deficiency - Hip and ridge shingles are damaged and missing. Recommend replacing as needed.

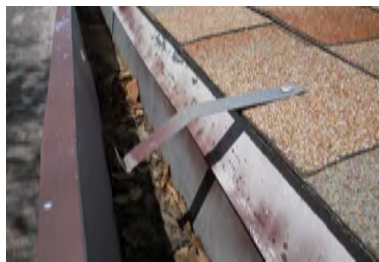
Typical Deficiency - Gutter brackets have been face fastened through asphalt shingle. Recommend removal and repositioning bracket. Repair asphalt shingles as needed.

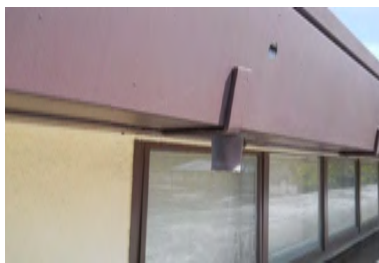
Typical Deficiency - Missing leader pipe. Recommend installation of leader pipe to divert water to lower roof.

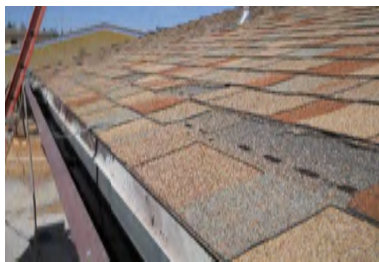
Typical Deficiency - Asphalt shingles are damaged and missing. Recommend replacing as needed.

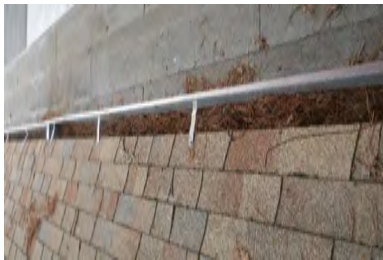
Typical Deficiency - Gutter brackets have been face fastened through asphalt shingle. Recommend removal and repositioning bracket. Repair asphalt shingles as needed.
Typical Deficiency - Gutters are full of debris. Recommend clearing debris from all gutters, drains, waterways, and field of roof to promote positive drainage.

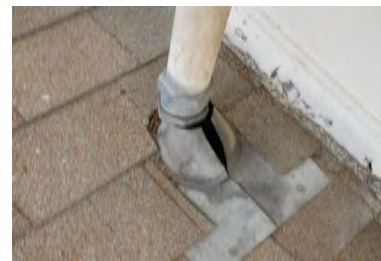
Typical Deficiency - Pipe jack is open. Recommend removal and replacement and installation of storm collar.

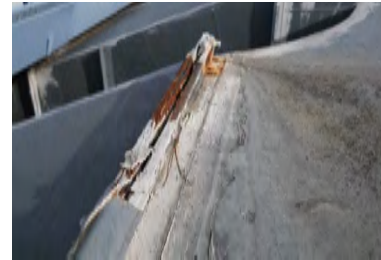
Typical Deficiency - Mechanical duct work seams damaged and deteriorated. Recommend replacement of damaged duct by licensed mechanical contractor and coating with acceptable silicone or acrylic coating.

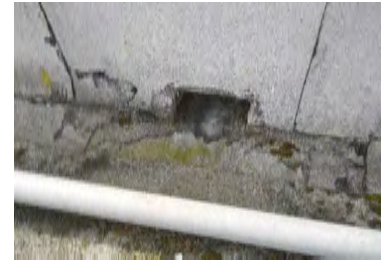
Typical Deficiency - Through wall scuppers should have debris screens. Recommend installation of gutter screens to promote positive drainage.

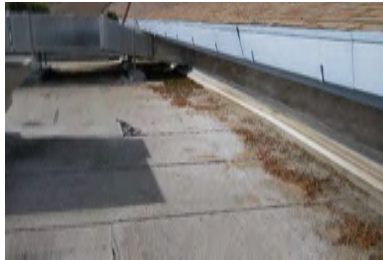
Typical Deficiency - Observed accumulation of debris at field of roof. Recommend clearing debris from all gutters, drains, waterways, and field of roof to promote positive drainage.

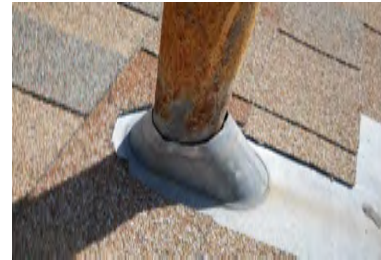
Typical Deficiency - Pipe jacks are missing sealant. Recommend application of flexible flashing self-adhered tape and or sealant, and install storm collar.

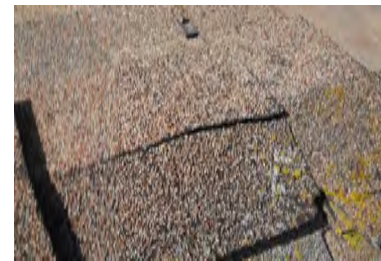
Typical Deficiency - Hip and ridge shingles are damaged and missing. Recommend replacing as needed.

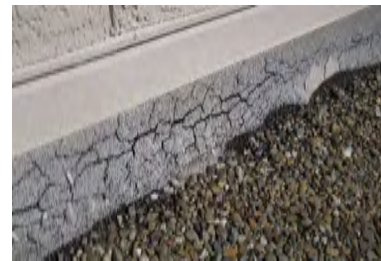
Typical Deficiency - Base flashings show signs of deterioration and cracking. Recommend application of silicone or acrylic coating to maximize usable life of existing built-up roof system.

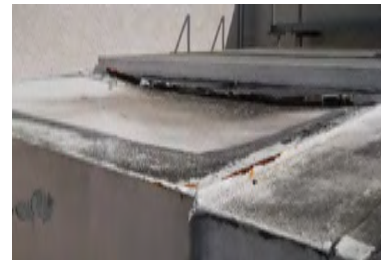
Typical Deficiency - Mechanical duct work damaged and deteriorated. Recommend replacement of damaged duct by licensed mechanical contractor and coating with acceptable silicone or acrylic coating.

Existing roof system is performing as designed, but nearing end of usable life. Observed accumulation of debris at waterways, gutters, drain assemblies, and field of roofing. Delamination of sealants around through roof penetrations. Mechanical duct needs to be repaired and or replaced by licensed contractor.

Recommend tear off of existing roofing and installation of new BUR roof system. Recommend additional evaluation of mechanical duct for repair and or replacement.

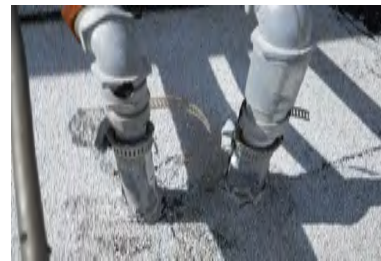
Typical Deficiency - Pipe jacks are missing sealant. Recommend application of flexible flashing self-adhered tape and or sealant, and install storm collar.

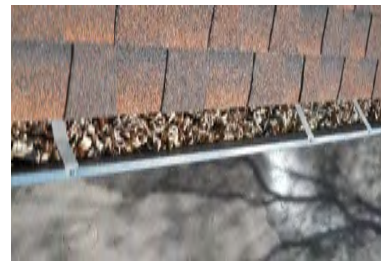
Typical Deficiency - Gutters are full of debris. Recommend clearing debris from all gutters, drains, waterways, and field of roof to promote positive drainage.

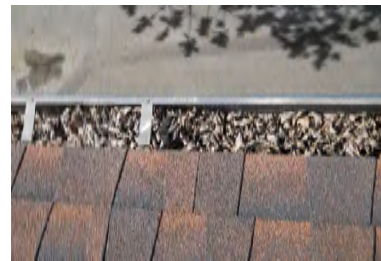
Typical Deficiency - Gutters are full of debris. Recommend clearing debris from all gutters, drains, waterways, and field of roof to promote positive drainage.

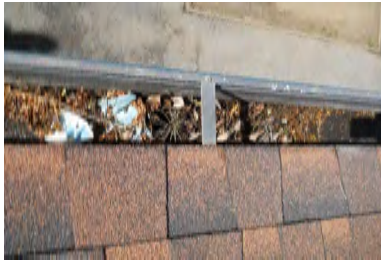
Typical Deficiency - Gutters are full of debris. Recommend clearing debris from all gutters, drains, waterways, and field of roof to promote positive drainage.

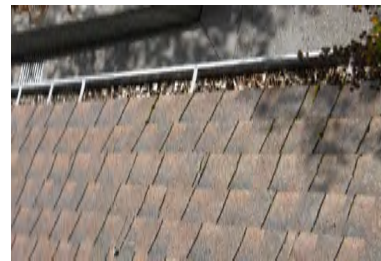
Typical Deficiency - Gutters are full of debris. Recommend clearing debris from all gutters, drains, waterways, and field of roof to promote positive drainage.

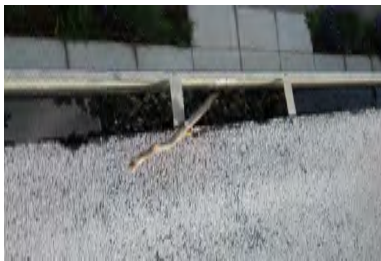
Typical Deficiency - Gutters are full of debris. Recommend clearing debris from all gutters, drains, waterways, and field of roof to promote positive drainage.

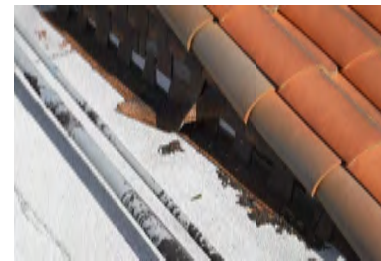
Typical Deficiency - Roof to wall transition has been improperly detailed. Recommend removing shingles and installing proper counterflashing assembly, roofing and wall finishes by others.

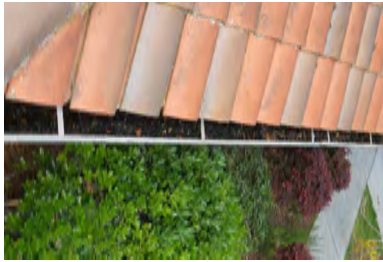
Typical Deficiency - Gutters are full of debris. Recommend clearing debris from all gutters, drains, waterways, and field of roof to promote positive drainage.

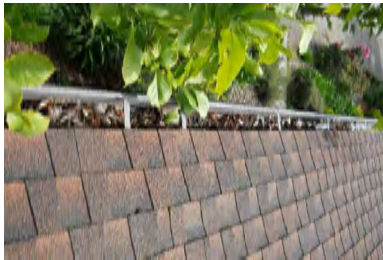
Typical Deficiency - Gutters are full of debris. Recommend clearing debris from all gutters, drains, waterways, and field of roof to promote positive drainage.

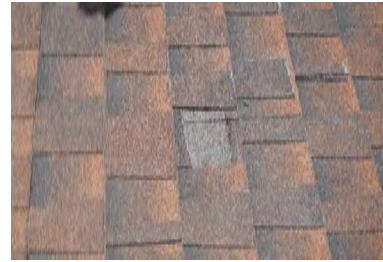
Typical Deficiency - Asphalt shingles are damaged and missing. Recommend replacing as needed.

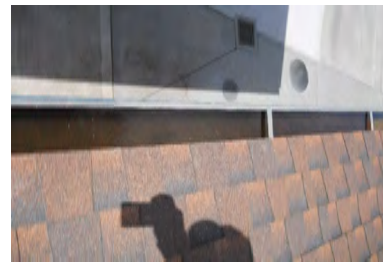
Typical Deficiency - Missing drop outlet and leader pipe. Recommend installation of drop outlet and leader pipe for drainage.

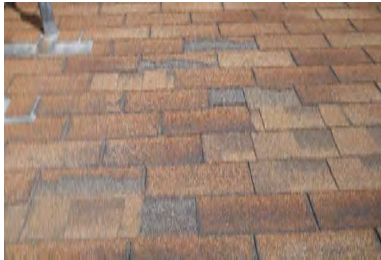
Typical Deficiency - Asphalt shingles are damaged and missing. Recommend replacing as needed.

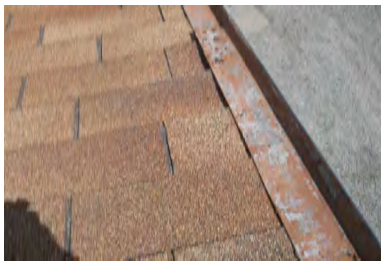
Typical Deficiency - Edge metal has been fastened directly through existing shingle roofing. Recommend metal removal, replacement, and roof repairs as needed.

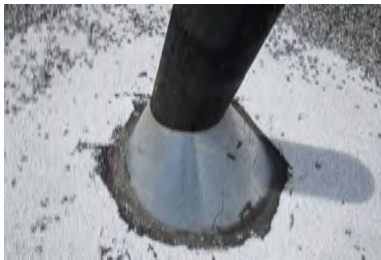
Typical Deficiency - Pipe jacks are missing sealant. Recommend application of flexible flashing self-adhered tape and or sealant, and install storm collar.

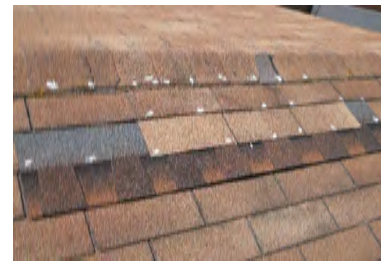
Typical Deficiency - Asphalt shingles are damaged and missing. Recommend replacing as needed.

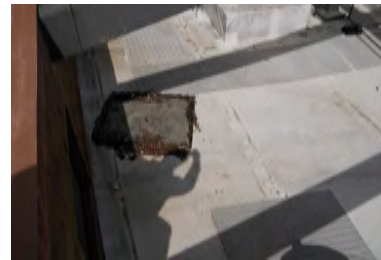
Typical Deficiency - Observed accumulation of debris at field of roof. Recommend clearing debris from all gutters, drains, waterways, and field of roof to promote positive drainage.

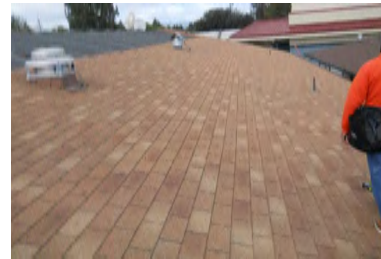
Typical Deficiency - Observed fastener penetrating through finished asphalt shingle roofing. Recommend removal and repair as needed.

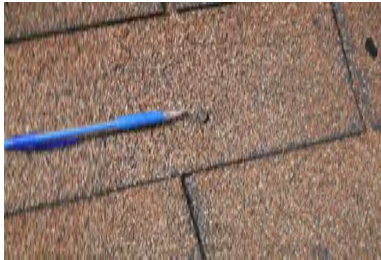
Typical Deficiency - Observed fastener penetrating through finished asphalt shingle roofing. Recommend removal and repair as needed.

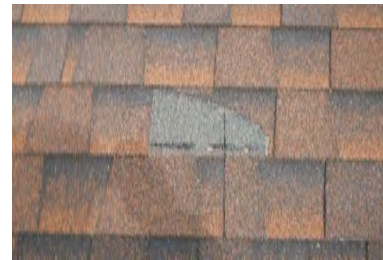
Typical Deficiency - Shingles are missing. Recommend replacing as needed.

Replace missing shingles as needed.

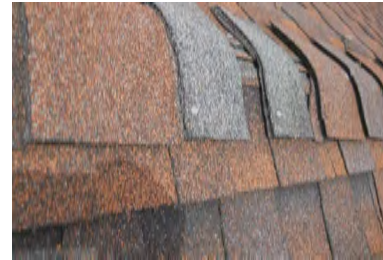
Typical Deficiency - Shingles are missing. Recommend replacing as needed.

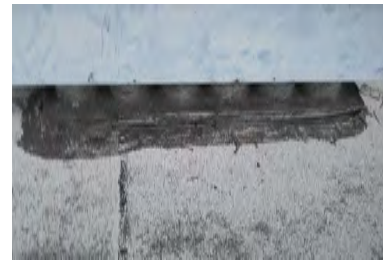
Typical Deficiency - Pitch pockets have dried up and sealant has pulled away from galvanized sheet metal flashing. Recommend removal and replacement of sealants.

Top off pitch pockets with modified mastic or compatible sealants as needed, coat with acrylic or silicone coating to preserve repair.

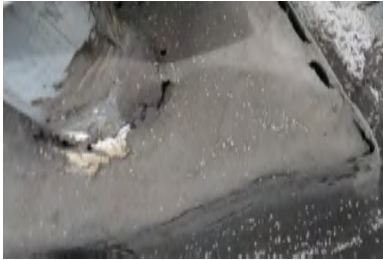
Typical Deficiency - Pitch pockets have dried up and sealant has pulled away from galvanized sheet metal flashing. Recommend removal and replacement of sealants.

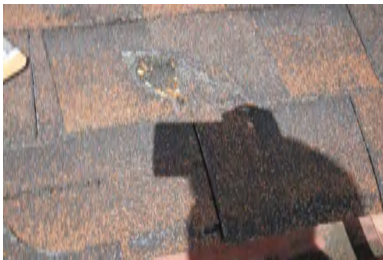
Typical Deficiency - Shingles are damaged. Recommend replacing as needed.

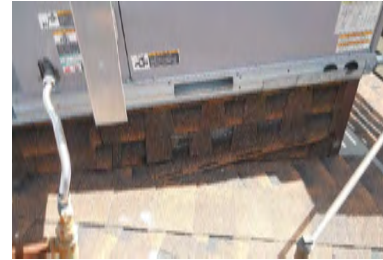
Typical Deficiency - Mechanical curbs have been improperly flashed. Recommend removal of shingles, install new sheet metal flashings properly tied into existing steep slope asphalt shingles.

Re-work improperly flashed mechanical curbs.

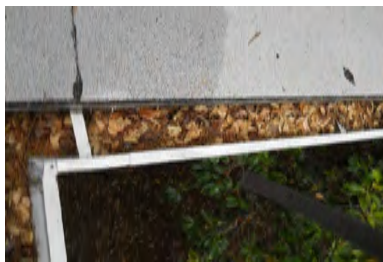
Typical Deficiency - Gutters are full of debris. Recommend clearing debris from all gutters, drains, waterways, and field of roof to promote positive drainage.

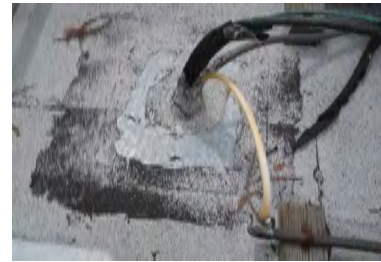
Typical Deficiency - Condenser line sets and electrical have not been flashed properly. Recommend installing galvanized pitch pocket with cover.

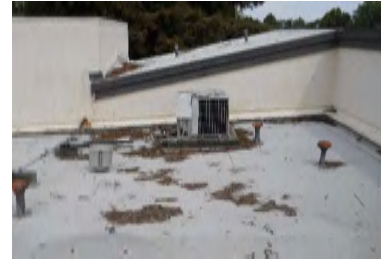
Typical Deficiency - Debris have accumulated on roofs. Recommend clearing debris from all gutters, drains, waterways, and field of roof to promote positive drainage.

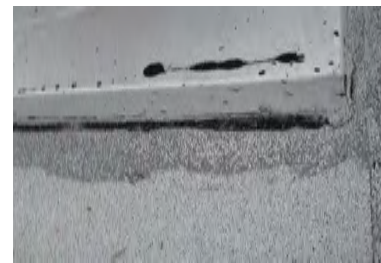
Typical Deficiency - Corner detailing at mechanical curb penetrations show signs of cracking and delamination. Recommend touch up of mastic and application of acrylic or silicone coating to preserve and maintain repair.

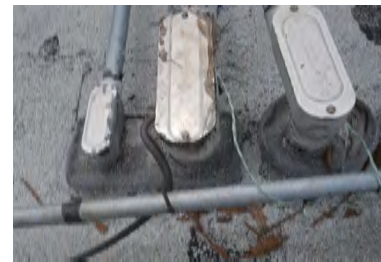
Typical Deficiency - LB electrical penetrations have not been flashed properly. Recommend installing galvanized pitch pocket with cover.

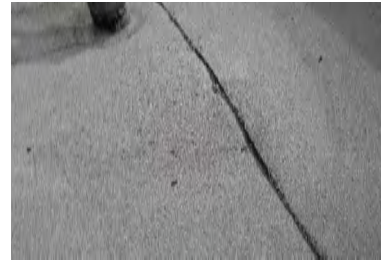
Typical Deficiency - Mineral surfaced cap sheet has blistered. Recommend relief cutting blister, imbed in layer of modified mastic, and apply target sheet of mineral surfaced cap sheet in cold applied adhesive.

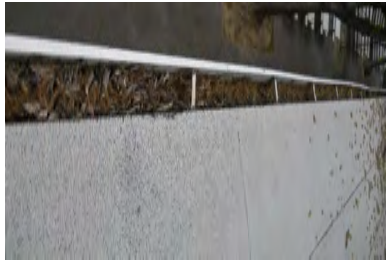
Typical Deficiency - Gutters are full of debris. Recommend clearing debris from all gutters, drains, waterways, and field of roof to promote positive drainage.

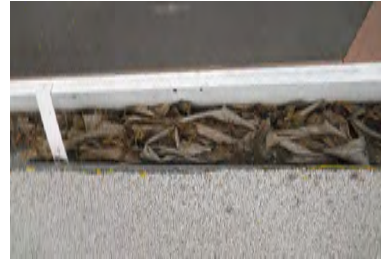
Typical Deficiency - Gutters are full of debris. Recommend clearing debris from all gutters, drains, waterways, and field of roof to promote positive drainage.

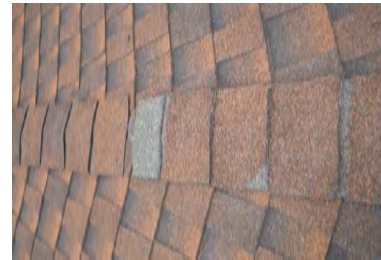
Typical Deficiency - Hip and ridge shingles are missing. Recommend replacing as needed.

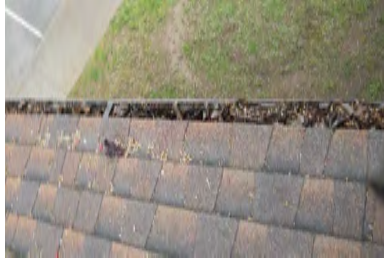
Typical Deficiency - Gutters are full of debris. Recommend clearing debris from all gutters, drains, waterways, and field of roof to promote positive drainage.

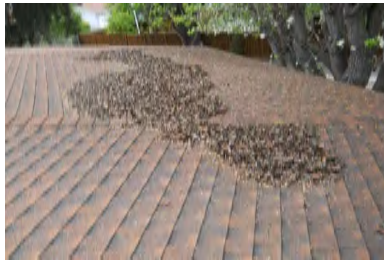
Typical Deficiency - Debris have accumulated on roofs. Recommend clearing debris from all gutters, drains, waterways, and field of roof to promote positive drainage.

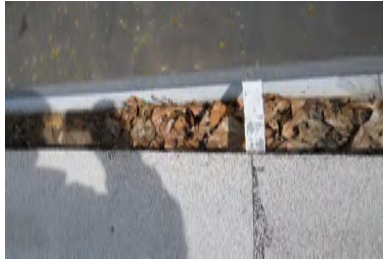
Typical Deficiency - Gutters are full of debris. Recommend clearing debris from all gutters, drains, waterways, and field of roof to promote positive drainage.

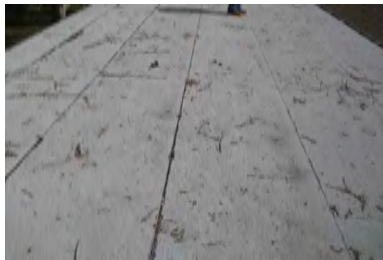
Typical Deficiency - Observed debris at field of roofing. Recommend clearing debris from all gutters, drains, waterways, and field of roof to promote positive drainage.

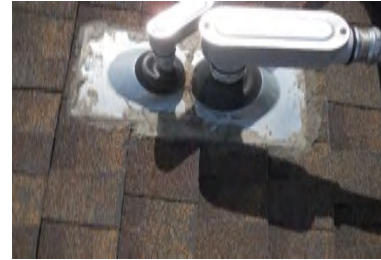
Typical Deficiency - Through roof penetrations has not been properly flashed. Recommend installing new roof jack and storm collar.

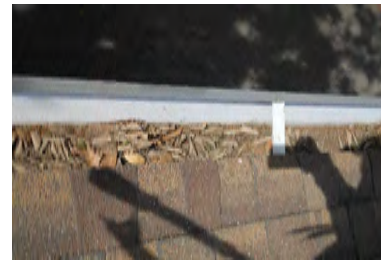
Typical Deficiency - Gutters are full of debris. Recommend clearing debris from all gutters, drains, waterways, and field of roof to promote positive drainage.

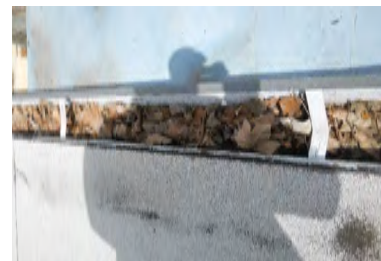
Typical Deficiency - Gutters are full of debris. Recommend clearing debris from all gutters, drains, waterways, and field of roof to promote positive drainage.

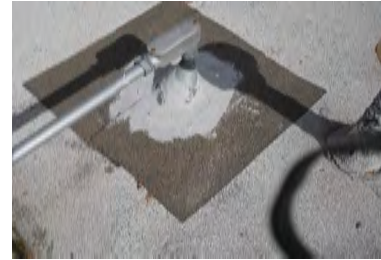
Typical Deficiency - Through roof penetrations has not been properly flashed. Recommend installing new roof jack and storm collar.

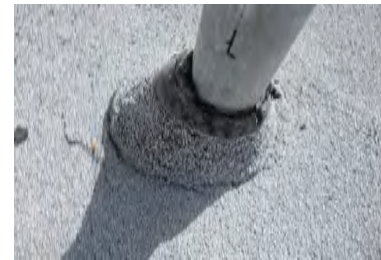
Typical Deficiency - Through roof penetration is open. Recommend resealing and installing storm collar.

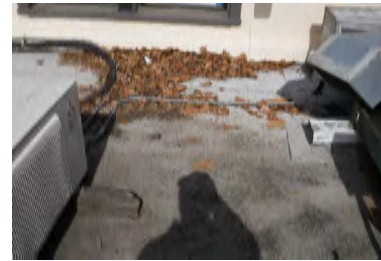
Typical Deficiency - Observed debris at field of roofing. Recommend clearing debris from all gutters, drains, waterways, and field of roof to promote positive drainage.

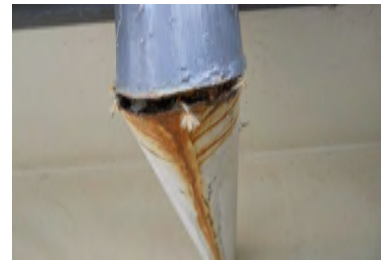
Typical Deficiency - Leader pipe seam is broken. Recommend repairing and or replacement.

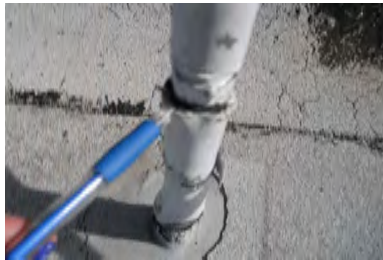
Typical Deficiency - Through roof penetration has not been properly sealed. Recommend re-sealing and installing storm collar.

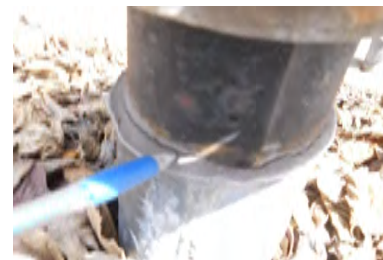
Typical Deficiency - Lead pipe jacks are missing band clamps and sealant. Recommend installing stainless steel band clamps, apply sealant, and install storm collar.

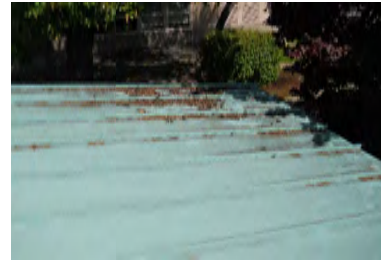
Typical Deficiency - Debris have accumulated at field of roof. Recommend clearing debris from all gutters, drains, waterways, and field of roof to promote positive drainage.

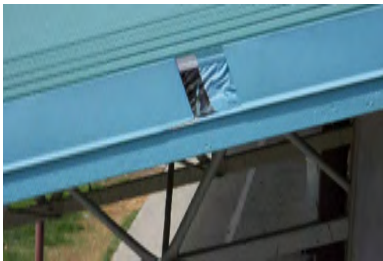
Typical Deficiency - Metal fascia detail is incomplete. Recommend repairing as necessary to provide a water tight application.

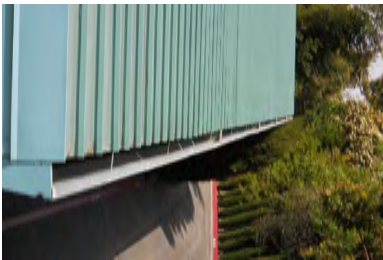
Typical Deficiency - Gutters are full of debris. Recommend clearing debris from all gutters, drains, waterways, and field of roof to promote positive drainage.

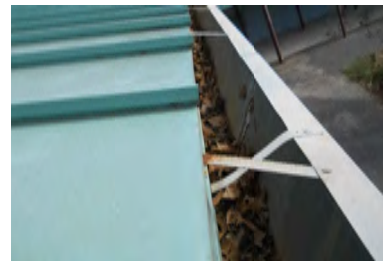
Typical Deficiency - Gutters are full of debris. Recommend clearing debris from all gutters, drains, waterways, and field of roof to promote positive drainage.

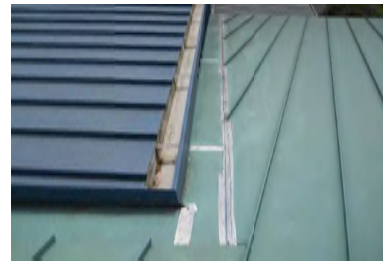
Typical Deficiency - Roof transition/ cricket has been temporarily sealed. Recommend removal of all temporary repairs and installation of as needed permanent repairs.

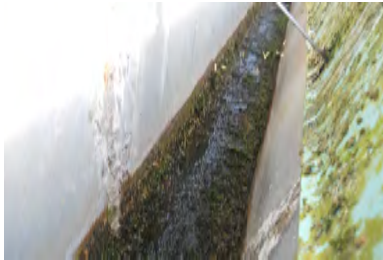
Typical Deficiency - Gutters are full of debris. Recommend clearing debris from all gutters, drains, waterways, and field of roof to promote positive drainage.

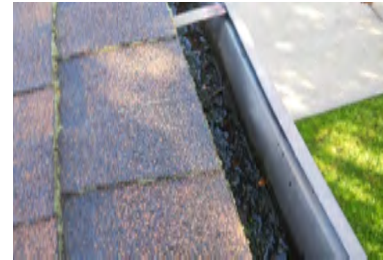
Typical Deficiency - Gutters are full of debris. Recommend clearing debris from all gutters, drains, waterways, and field of roof to promote positive drainage.

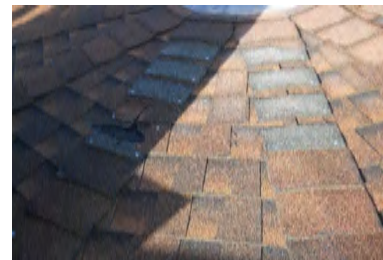
Typical Deficiency - Hip and ridge shingles are missing. Recommend replacing as needed.

Replace missing shingles as needed.

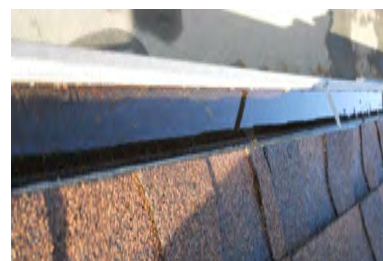
Typical Deficiency - Gutters are full of debris. Recommend clearing debris from all gutters, drains, waterways, and field of roof to promote positive drainage.

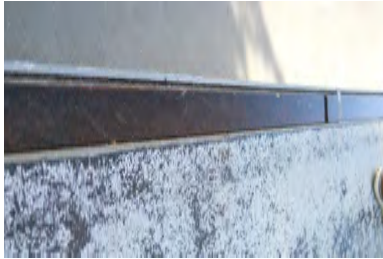
Typical Deficiency - Gutters are full of debris. Recommend clearing debris from all gutters, drains, waterways, and field of roof to promote positive drainage.

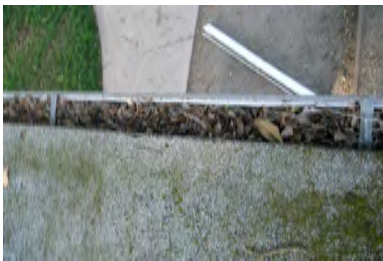
Typical Deficiency - Gutters are full of debris. Recommend clearing debris from all gutters, drains, waterways, and field of roof to promote positive drainage.

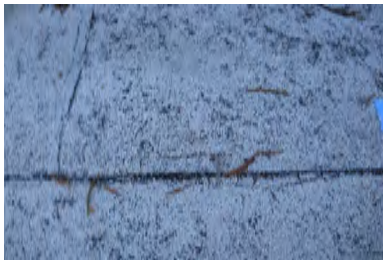
Typical Deficiency - Blister between BUR plies. Recommend relieving blister, dry moisture, imbed ply in modified mastic, and apply sacrificial protection membrane in cold adhesive.

Existing roof system is performing as designed. Observed accumulation of debris at waterways, gutters, drain assemblies, and field of roofing. Blistered cap sheet in 1 area. Substantial granule loss at mineral surfaced cap sheet.

Repair blistered membrane.

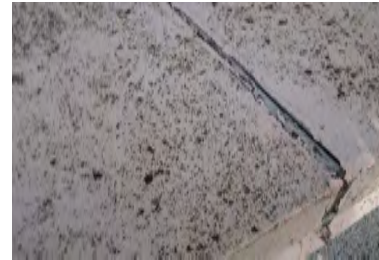
Typical Deficiency - Sealant at coping seams has begun to fail. Recommend removal and replacement of sealant as needed.

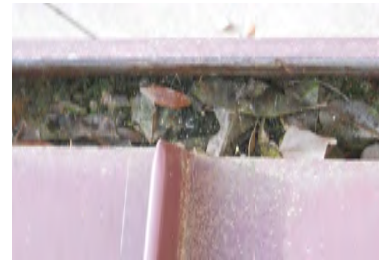
Typical Deficiency - Gutters are full of debris. Recommend clearing debris from all gutters, drains, waterways, and field of roof to promote positive drainage.

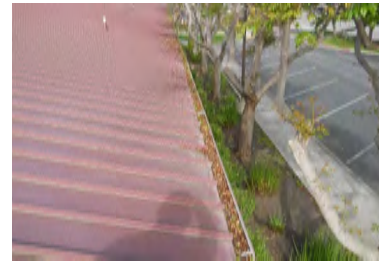
Typical Deficiency - Gutters are full of debris. Recommend clearing debris from all gutters, drains, waterways, and field of roof to promote positive drainage.

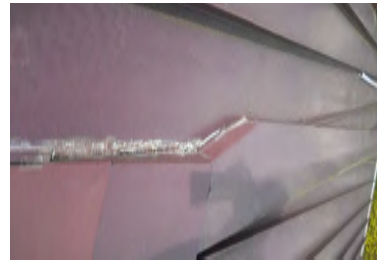
Typical Deficiency - Roof transition/ cricket has been temporarily sealed. Recommend removal of all temporary repairs and installation of as needed permanent repairs.

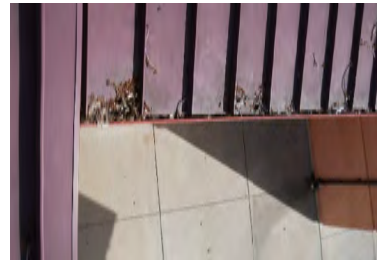
Typical Deficiency - Gutters are full of debris. Recommend clearing debris from all gutters, drains, waterways, and field of roof to promote positive drainage.

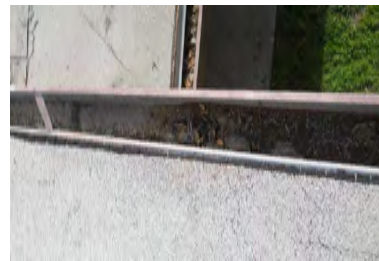
Typical Deficiency - Gutters are full of debris. Recommend clearing debris from all gutters, drains, waterways, and field of roof to promote positive drainage.

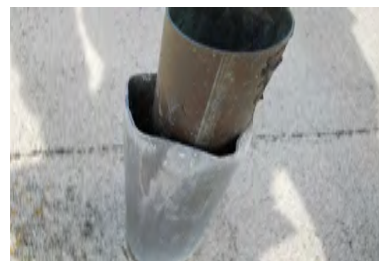
Typical Deficiency - Pipe jacks are missing sealant. Recommend application of flexible flashing self-adhered tape and or sealant, and install storm collar.

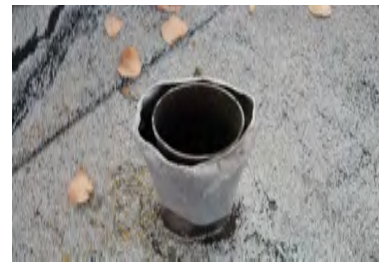
Typical Deficiency - Pipe jacks are missing sealant. Recommend application of flexible flashing self-adhered tape and or sealant, and install storm collar.

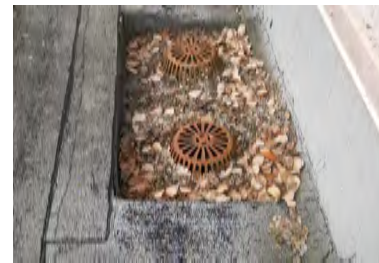
Typical Deficiency - Debris have accumulated at field of roof. Recommend clearing debris from all gutters, drains, waterways, and field of roof to promote positive drainage.

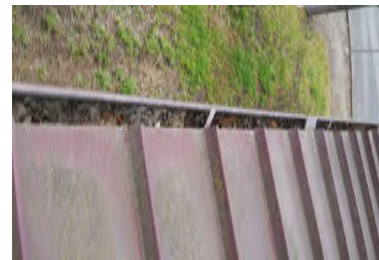
Typical Deficiency - Gutters are full of debris. Recommend clearing debris from all gutters, drains, waterways, and field of roof to promote positive drainage.

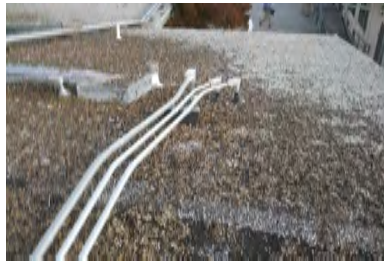
Typical Deficiency - Debris have accumulated at field of roof. Recommend clearing debris from all gutters, drains, waterways, and field of roof to promote positive drainage.

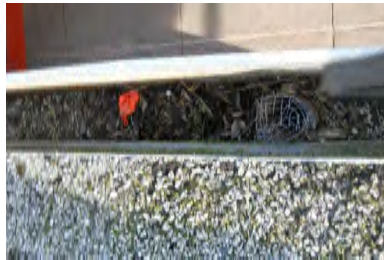
Typical Deficiency - Gutters are full of debris. Recommend clearing debris from all gutters, drains, waterways, and field of roof to promote positive drainage.

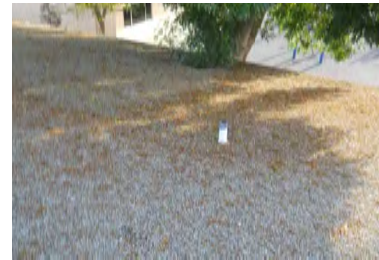
Typical Deficiency - Debris have accumulated at field of roof. Recommend clearing debris from all gutters, drains, waterways, and field of roof to promote positive drainage.

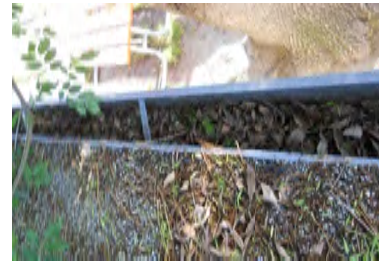
Typical Deficiency - Gutters are full of debris. Recommend clearing debris from all gutters, drains, waterways, and field of roof to promote positive drainage.

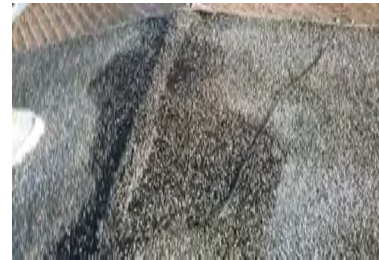
Typical Deficiency - Areas of displaced gravel. Recommend re-distributing and adhering gravel over bare areas to protect underlying membrane from exposure to UV .

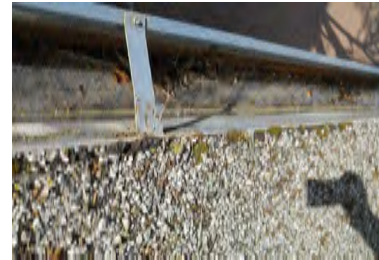
Typical Deficiency - Gutters are full of debris. Recommend clearing debris from all gutters, drains, waterways, and field of roof to promote positive drainage.

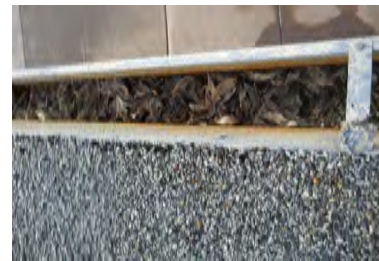
Typical Deficiency - Gutters are full of debris. Recommend clearing debris from all gutters, drains, waterways, and field of roof to promote positive drainage.

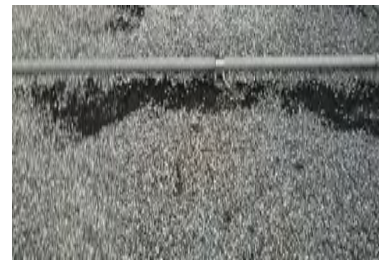
Typical Deficiency - Areas of displaced gravel. Recommend re-distributing and adhering gravel over bare areas to protect underlying membrane from exposure to UV .

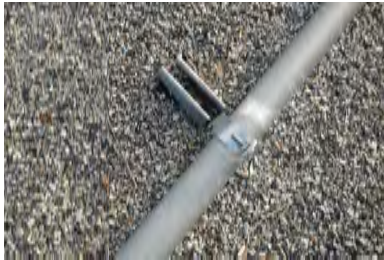
Typical Deficiency - Unistrut supports have been fastened directly through existing roof system. Recommend removal, repair of roof and refastening support to sleeper, floating block, etc..

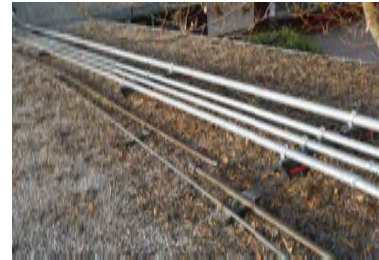
Typical Deficiency - Debris have accumulated at field of roof. Recommend clearing debris from all gutters, drains, waterways, and field of roof to promote positive drainage.

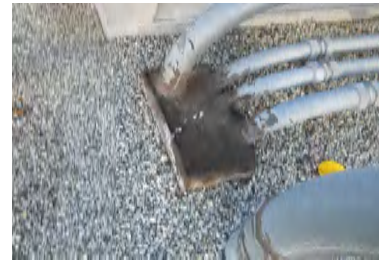
Typical Deficiency - Pitch pocket sealants have dried out and pulled away from flashing. Recommend topping off pitch pocket with compatible sealer or modified mastic and application of acrylic or silicone coating to preserve and maintain repair.

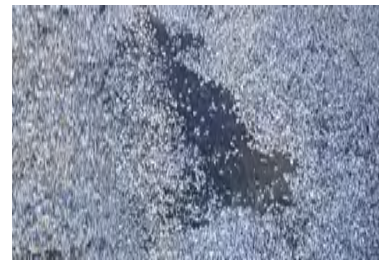
Typical Deficiency - Areas of displaced gravel. Recommend re-distributing and adhering gravel over bare areas to protect underlying membrane from exposure to UV .

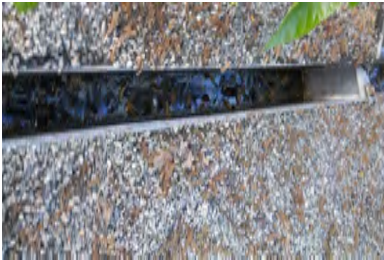
Typical Deficiency - Gutters are full of debris. Recommend clearing debris from all gutters, drains, waterways, and field of roof to promote positive drainage.

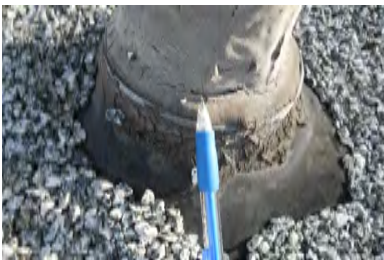
Typical Deficiency - Detailing at through roof penetrations show signs of cracking and delamination. Recommend touch up of mastic at penetrations and application of acrylic or silicone coating to preserve and maintain repair.

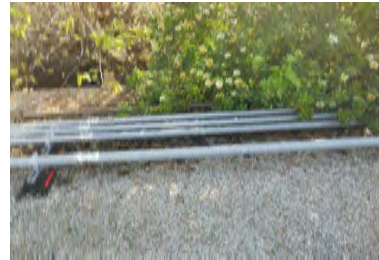
Typical Deficiency - Debris have accumulated at field of roof. Recommend trimming trees back from roof eaves, clearing debris from all gutters, drains, waterways, and field of roof to promote positive drainage.

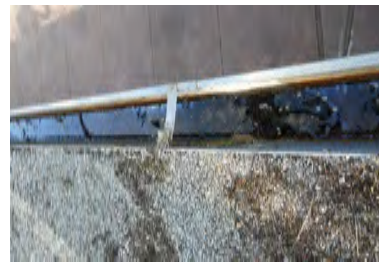
Typical Deficiency - Gutters are full of debris. Recommend clearing debris from all gutters, drains, waterways, and field of roof to promote positive drainage.

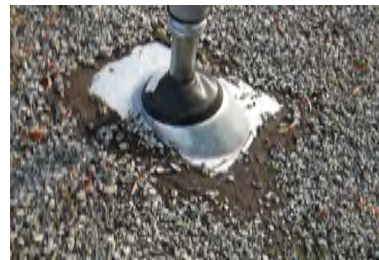
Typical Deficiency - Through roof penetrations do not appear to have proper roof jack. Recommend installing proper roof jack and storm collar.

Remove and replace incorrect roof jacks.

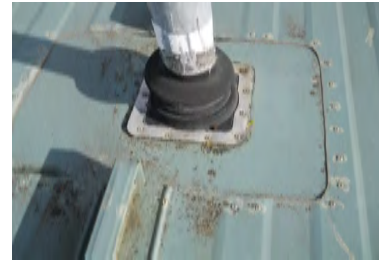
Typical Deficiency - Detailing at through roof penetrations show signs of cracking and delamination. Recommend touch up of sealants..

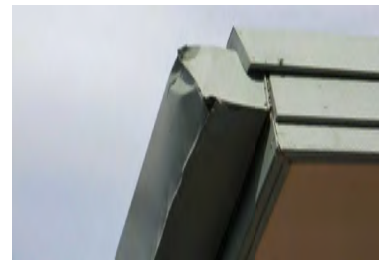
Typical Deficiency - Corner of gutter is damaged. Recommend repair and seal as needed.

Repair gutter as needed.

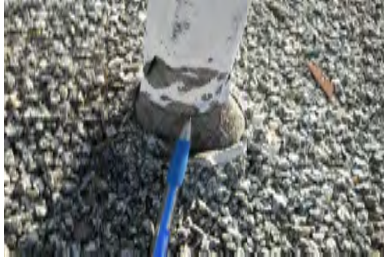
Typical Deficiency - Detailing at through roof penetrations show signs of cracking and delamination. Recommend touch up of mastic at penetrations and application of acrylic or silicone coating to preserve and maintain repair.
